## Did you know that Infrared heat helps airbags to inflate more easily?

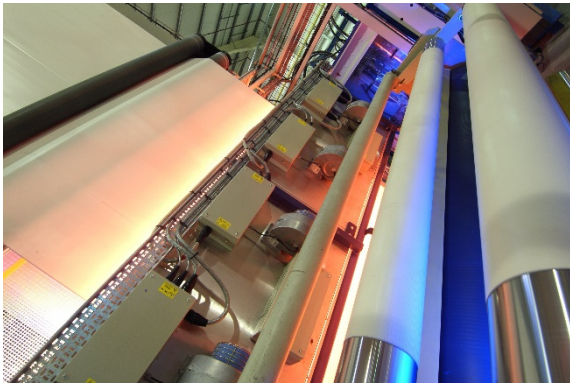
In an accident, it is important, that an airbag inflates immediately. The silicone coating plays there a major roll. Airbags are made out of a fabric, which is coated with silicone. This smooth coating ensures that the cushion will unfold fast and without sticking when deployed. This fabric is called Nylon 66. Nylon 66 is very hydroscopic, this is causing a problem at the coating stage for the heavier cloth used for inflatable curtains. It is necessary to reduce the cloth's moisture content down to 2% to ensure the correct adhesion, drying and surface finish of the silicone coating and to reduce scrap levels. In operation, the infrared system is controlled by an optical pyrometer, which measures the surface temperature of

the fabric and then transmits a signal to regulate the power of emitters within the infrared module, which is mounted above the fabric web. The cloth is coated with silicone on both sides but the critical heating operation takes place just before the coating is applied to the bottom side. It is essential that the moisture is removed before this bottom coating is applied, otherwise it will be sealed in, potentially causing damage to the final surface finish. The infrared module can be retrofitted very easily into an existing coating line, and the fast response of the carbon emitters means that there is no damage to the coated fabric in the event of unexpected line stoppage.
